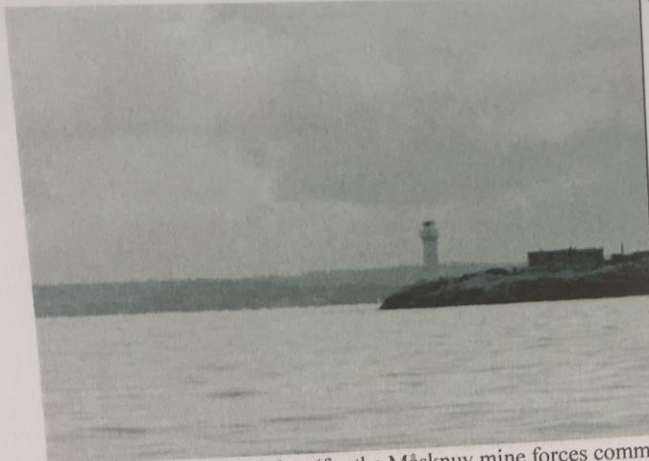
Left: lighthouse and bunker (for the Måsknuden mine forces command at Målsten). The mine detonation on 11 October 1982 (photo: 12 October 1982 taken from *Amalia*)²²⁰ took place 100 meters left of the island. Right, the document from the helicopter Y46 showing the expansion of the green patch (the green "sea-marker dye") 13:45-15:00, while moving 1 km northwards. At 13:45, it was 10 meter from the island.²²¹

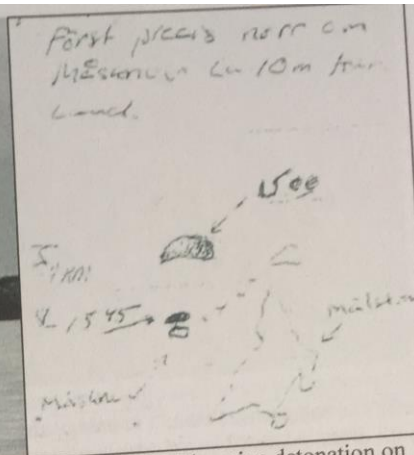
Left: the expansion of the green dye from 13:45 to 15:00. It would have appeared on the surface around 13:30 at a position where *Belos* found possible steel plates 1-1.5 meters with its sonar. Right: U.S Navy instructions for "Event Subsunk" ("Sighting green dye marker", US Navy Operations Specialist, note 67).

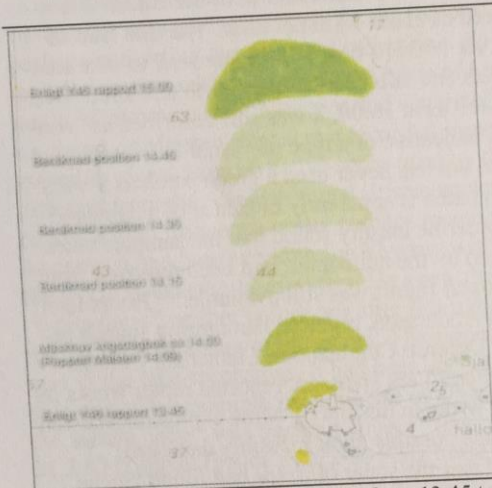
EVENT SUBSUNK

If any of the following conditions are met, **EVENT SUBSUNK** must be started:

1. A submarine fails to surface promptly, following a known accident.
2. There is reason to suspect that a submarine has suffered a casualty and requires assistance. Indications of a submarine disaster that call for the immediate execution of **EVENT SUBSUNK** include:
 - a. Sighting a submarine messenger buoy.
 - b. Sighting green dye marker.
 - c. Sighting a distress pyrotechnic (red) fired from a submarine.
